## Subordinate & Tertiary Loops - The Hidden Legionella Risk?

### A WHITE PAPER

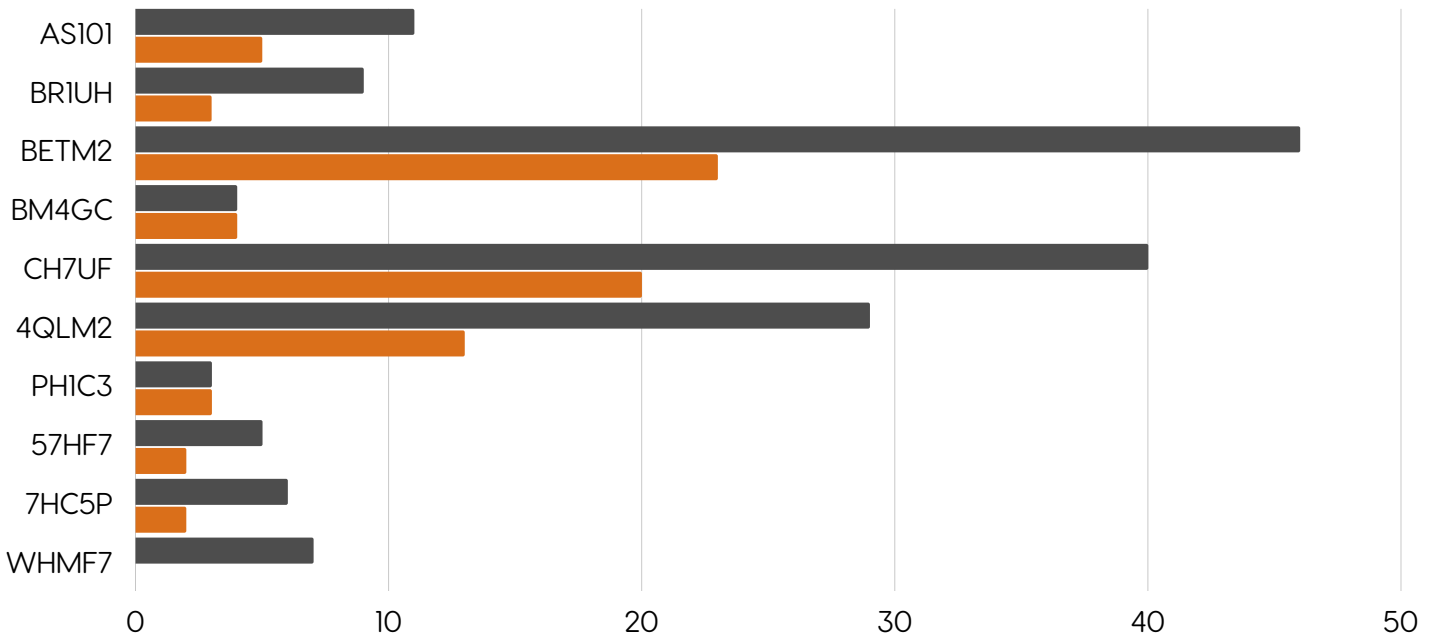
Hot return temperatures on subordinate and tertiary loops should consistently maintain a minimum of 50°C (55°C in Healthcare premises) to ensure that Legionella bacteria is controlled within the circulating portions of the system. The remote monitoring sensors clearly identify when there is an issue with the hot return loops whereby the consistent data exhibits how the temperature will increase with the hot flow when the faucet is opened but fail to retain the temperature after the flushing event. Often declining completely to the original ambient temperature until the outlet is used again.
